Quando la conservazione incontra un edificio con curtain wall. Il caso di Torre Galfa in Milano

When Preservation Meets a 20th-Century Building with Curtain Wall. The Case of the Torre Galfa in Milan

Davide Del Curto, Chiara Stanga

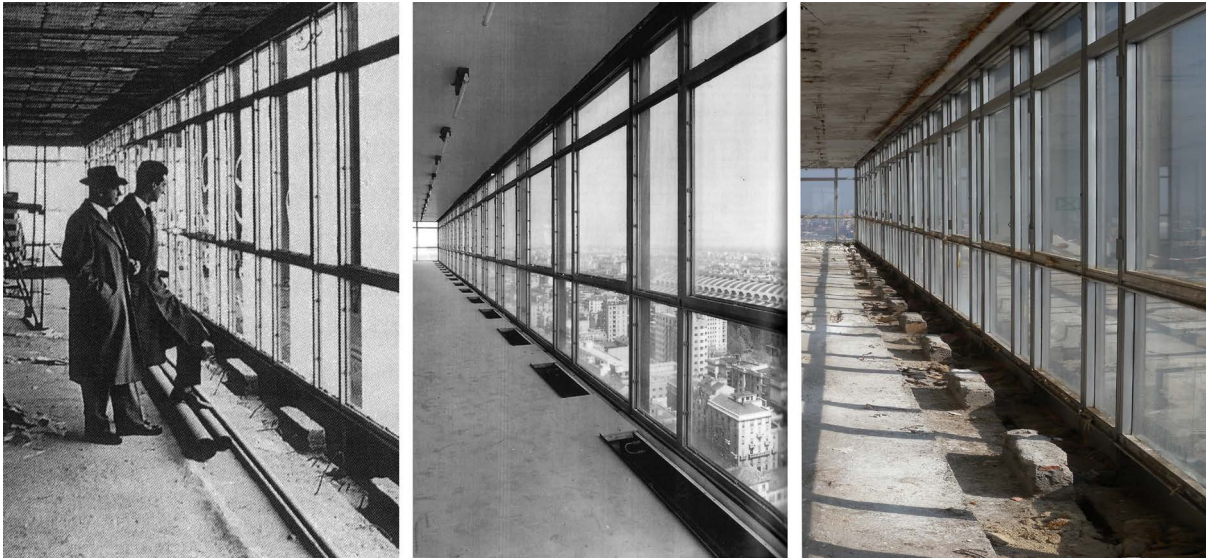
Despite years of neglect, nowadays both the metal and glass components are mostly well preserved. On the other hand, the iron elements connecting the curtain wall to the slab are affected by corrosion and the rubber gaskets are mostly vulcanized (fig. 6).

Figure 6. Galfa Tower curtain wall. Comparison among building site (GRECO, MORNATI 2012, p. 93, left), interiors in 1959 (GRECO, MORNATI 2012, p. 122, middle), interiors in 2015 (Photo D. Del Curto, right).

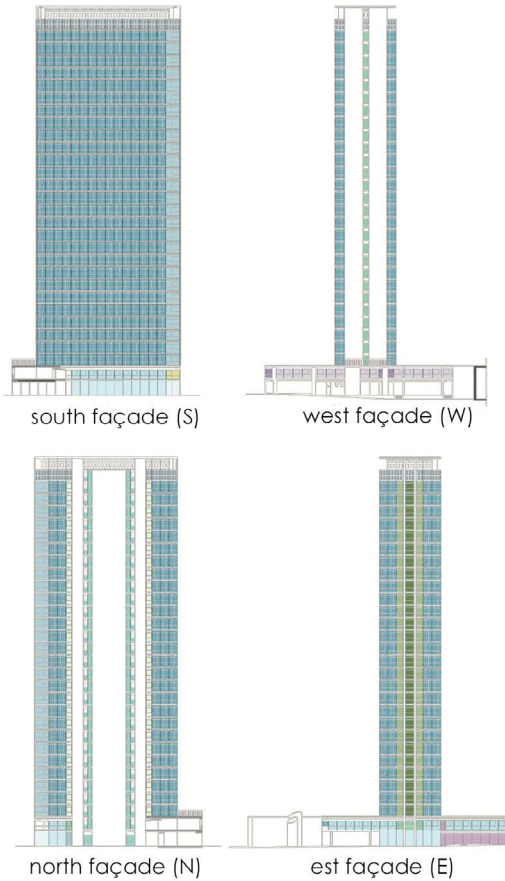
Despite the uniform appearance, the façade is composed of eight different windows modules (fig. 7). Each module was measured and drawn at 1:20 scale. Some details, e.g. the joint between mullion and transom, were drawn at 1:5-1:2 scale. The ground floor presents a window type (Single Module) as tall as the storey. Single Module can be subdivided in four sub-typologies: Basic, Small, Large, and Longitudinal. The first floor has a Tripartite Module (sub-typologies: Basic, Small, Horizontal) and a Bipartite Module (Basic, Small, Large, Horizontal). The Basic sub-type (225x246 cm) was employed both for the first storey of the Tower and for the East façade of the minor building parallel to Galvani street. It is made of a parapet (102 cm height) and two panes on the upper side: a fixed pane 75 x 145 cm and a single casement 145x150 cm. The Tripartite Module (sub-type: horizontal) dominates the West façade of the minor building parallel to Galvani street. It differs from the others because it lacks

Figure 7. Curtain wall-windows typological analysis, comparison among the different modules. In the third column building T is Galfa Tower, building L is via Galvani wing (elaboration by the authors, together with arch. Chiara Spinelli).

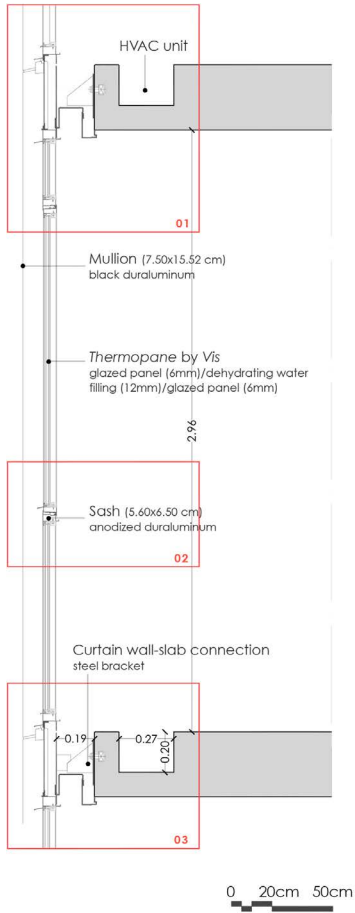
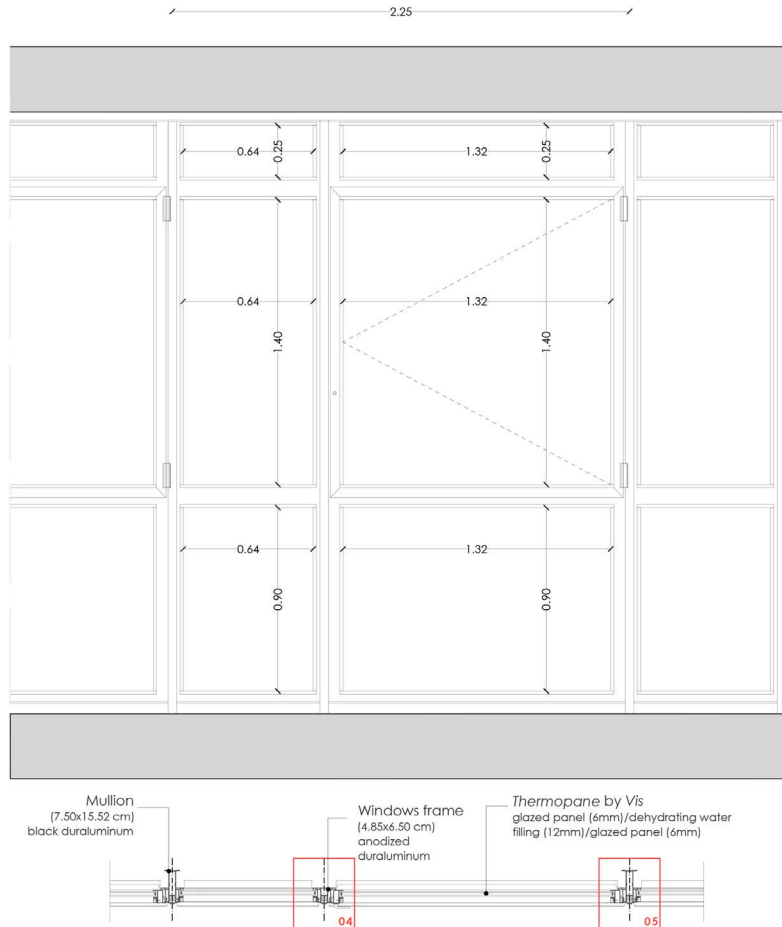
The Six-Party Module covers the Tower from the 3rd to the 28th storey (sub-types: Basic, Large, Ventilation system). The Basic sub-type (fig. 8-10) is the most used. This sub-type can be divided into six sectors, two vertically, and three horizontally. The parapet height is 102 cm, like the one of the other sub-types. The pane height is 134 cm. The fanlight height is 48 cm. The fixed pane width is 45 cm. The casement width is 139 cm. The vertical mullion therefore divides this module into two sides of different width (one fixed and the other openable). These modules were installed as vertically mirrored from one storey to the other. This way, the vertical mullions of the even and odd floors are not aligned, and the overall design of the aluminum façade is more dynamic. The Six-Party (subtype: Large) is employed to adjust the Six-Party Module to the overall layout of the curtain wall at the northern and southern corners, where a special module is needed, since the space is wider comparing to the Six-Party Module (sub-type: basic). The same happens for the northern and southern corners of the first storey, where a Quadripartite Module was thus used. The Six-Party (sub-type: Ventilation system) is applied to the northern façade from the ground floor to the 29th storey. It has the left pane filled with a ventilation grid instead of a glass. A Bipartite Module (sub-type: Basic) made the parapet of the 30th storey (terrace).

Figure 8. As-built drawing of the Six-party Module (elaboration by the authors, together with arch. Chiara Spinelli).

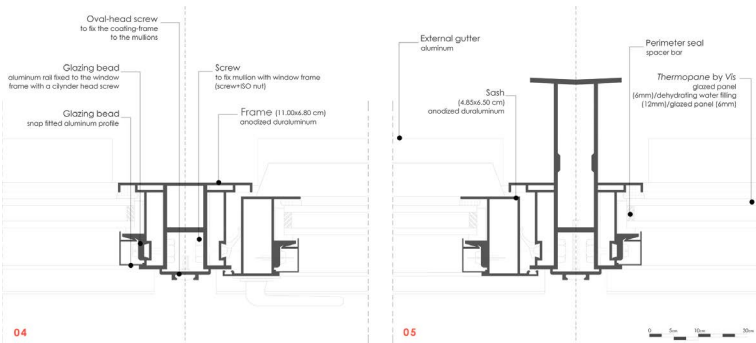
Above, figure 10. As-built drawing of the Six-party Module, detail (cross section) (elaboration by the authors, together with arch. Chiara Spinelli).

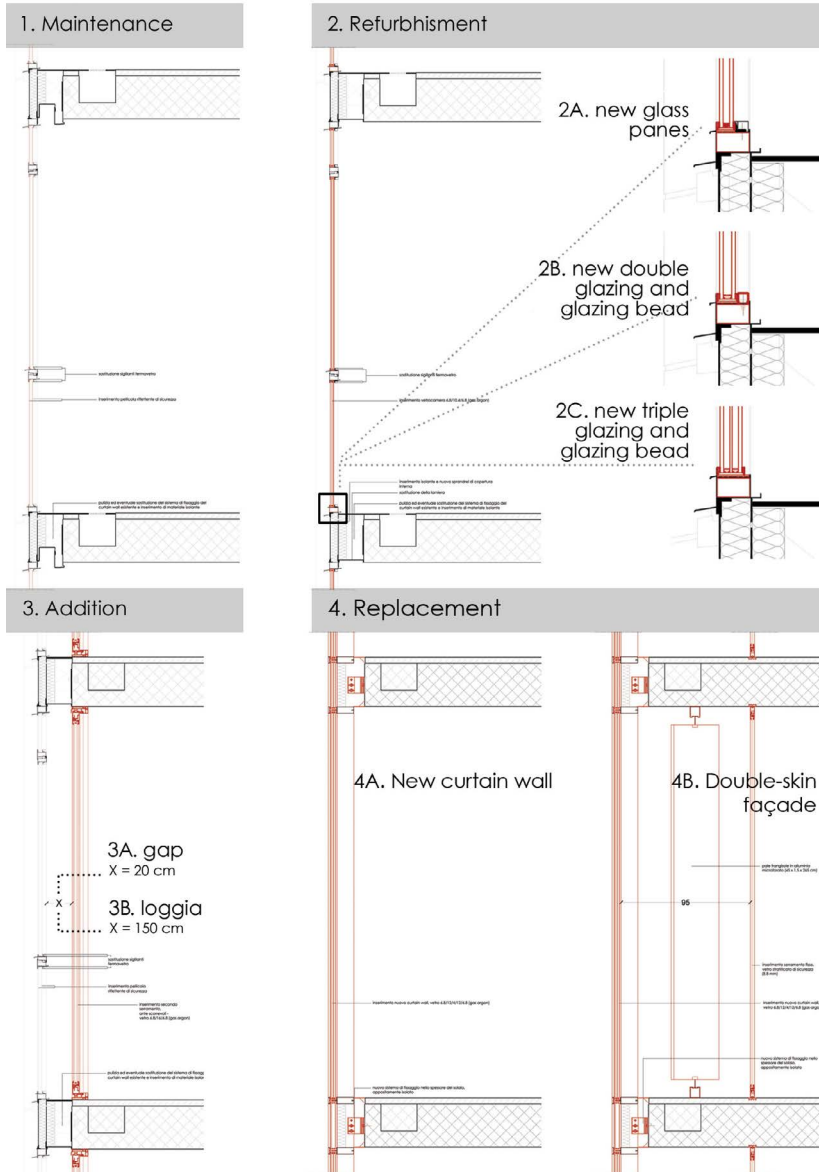
Figure 11. Scenarios of intervention. Comparative table: 1. Maintenance, 2. Refurbishment, 3. Addition, 4A. New curtain wall, 4B. Double-skin façade (elaboration by the authors).

1. Maintenance provides a minimum intervention on the existing curtain wall and consists with the application of a reflectivity safety film on the inner side of the glass panes. This improves the energy efficiency and safety performances. Decayed gaskets are replaced with new ones and if necessary new gaskets are added. Duralumin components are cleaned and re-anodized. Curtains will be re-installed according to the original design.

2. Refurbishment aims at replacing the double glazing with a new and more performant one. The first sub-category (2.A) keeps the existing spacer, while double glazing is replaced by a new one, but the original width is maintained (24 mm). In the second sub-category (2.B) the double glazing is replaced by a thicker one, and thus a wider spacer. Due to this increase in width (29,6 mm), also the internal glazing bead is changed with a smaller one. The third sub-category (2.C) replaces the existing windows with thermal break aluminum profile and third glazing (41,6 mm) and replaces the glazing beads with new ones.

3. Addition keeps the existing curtain wall (same interventions for Maintenance) and introduces a second double glazing casement with thermal break aluminum profile, placed on the backward of the existing curtain wall, in order not to change the envelope materials, constructive techniques and external aspect. The two sub-categories present differences in the distance between the existing curtain wall and the new windows: 20 cm in the first case (3.A) and 150 cm in the second one (3.B). The choice between those two depends on the way the architectural space is conceived: the first solution can be considered as a ventilated façade with airing grills and darkening integrated system. The second implies the creation of a glazed loggia, thus a new interior to be designed, e.g. in form of a greenhouse.

4. Replacement presents two sub-options: the first one (4.A) consists in replacing the existing curtain wall with a new and more performant one. The new façade has a triple glazing and aluminum profile with thermal break, being characterised by the same architectural layout. The second one (4.B) replaces the existing curtain wall with new double-skin façade. This is made of: (i) a new curtain wall, with the same characteristics of the previous solution, and (ii) a new single-glazed window with

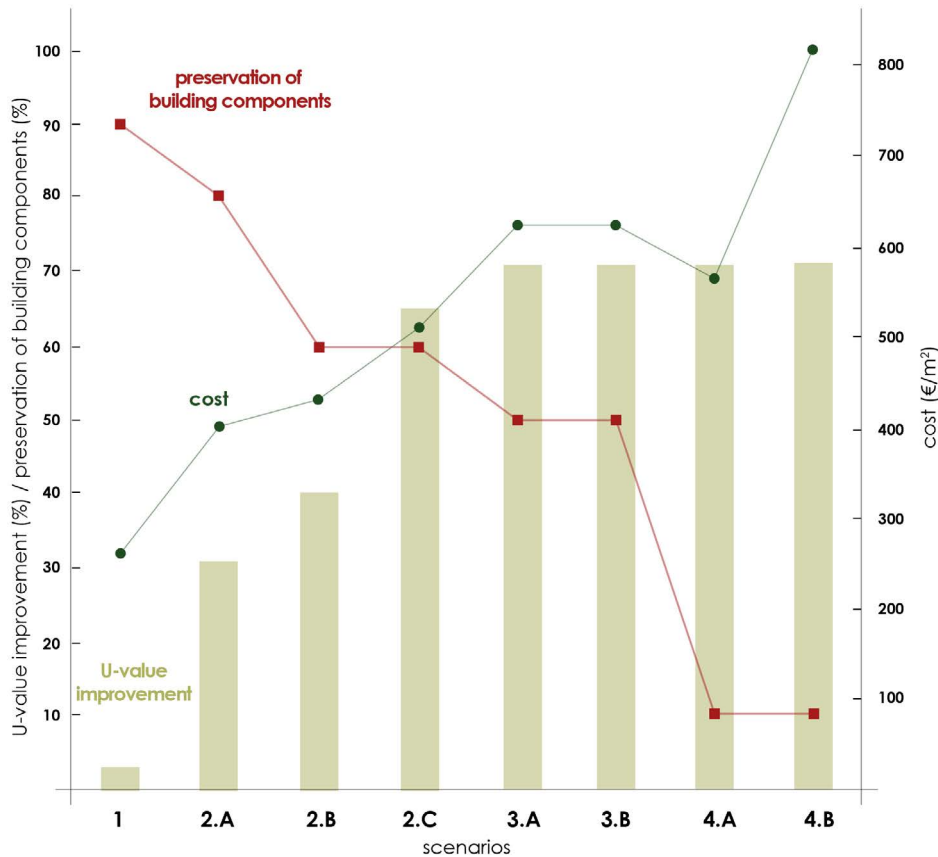
The results obtained with each scenario are compared in figs. 14, 15. In fig. 15, the different scenarios are indicated on the X axis. The cost is indicated on the Y axis, right side and represented by the green line. The energy improvement is indicated on the Y axis, left side and represented by green columns. The preservation of the building components and materials is represented by the red line. The preservation of the building components and materials trend is highest for Scenario 1-Maintenance, and it decrease for Scenario 4-Replacement. On the contrary, costs are minimum for Scenario 1 and maximum for Scenario 4.

Figure 15. Comparative chart among different scenarios (elaboration by the authors).
