Le superfici esterne negli edifici residenziali progettati da Giuseppe Terragni. Intonaci, rivestimenti in pietra e elementi prefabbricati alla prova del tempo

Marta Casanova (Università degli Studi di Genova)

The Outer Surfaces of the Residential Buildings Designed by Giuseppe Terragni. Plasters, Stone Cladding and Prefabricated Elements to the Test of Time

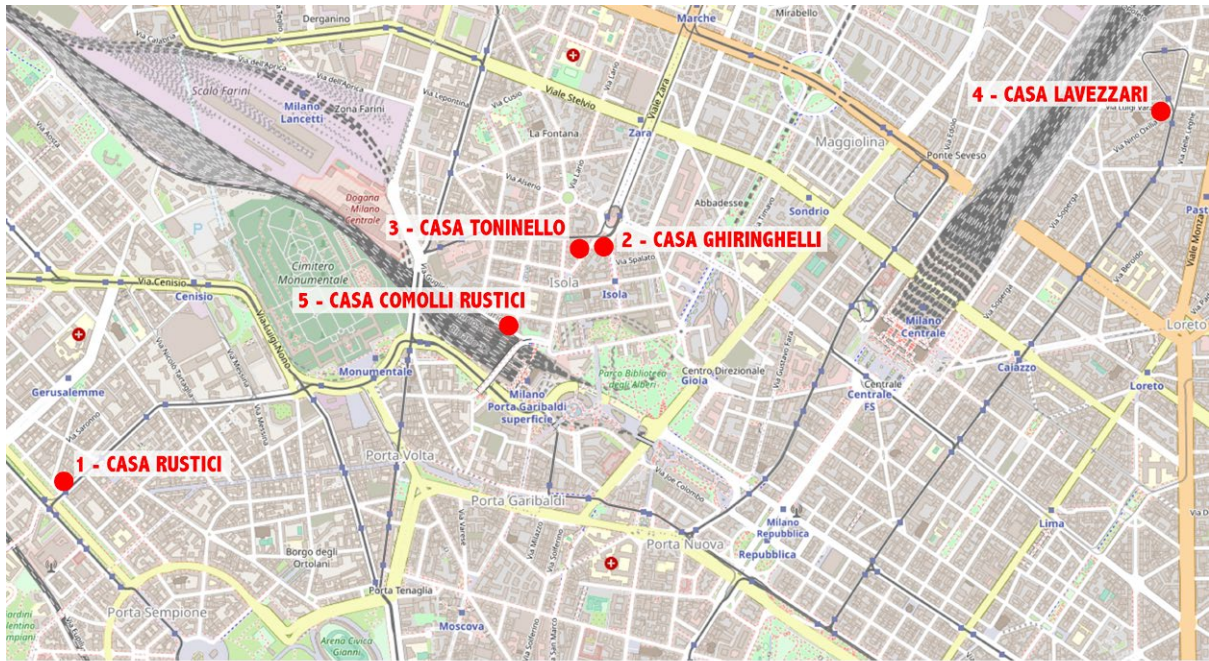
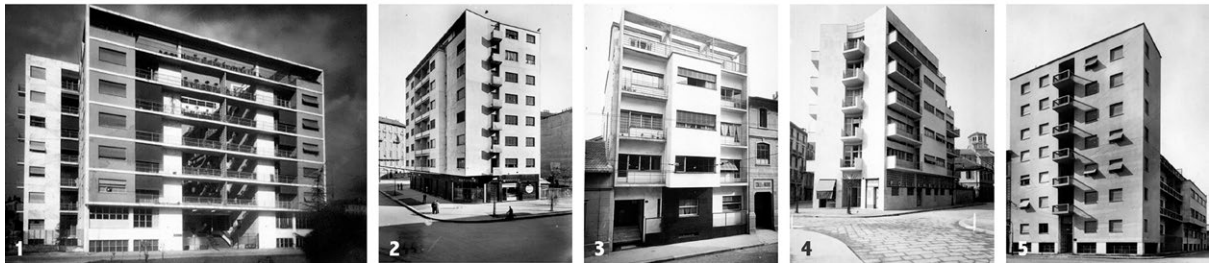
Figure 3. Map of the area in the North of the historic centre of Milan, with identification of the five residential buildings designed by Terragni and Lingeri. Photographs of the buildings at the end of the constructions (AGT, photographs, Casa Rustici, Casa Ghiringhelli, Casa Toninello, Casa Lavezzari, Casa Comolli Rustici).

The five apartment buildings designed with Pietro Lingeri and built in Milan between 1933 and 1938 (fig. 3): Casa Ghiringhelli¹², Casa Toninello¹³, Casa Rustici¹⁴, Casa Lavezzari¹⁵ and Casa Comolli Rustici¹⁶, are located in the area in the North of the historic centre between Corso Sempione, the Isola district and Morbegno square to the East. For these buildings it was not possible to consult the planning documentation, which had been lost in the bombing of Lingeri Study in Milan, but the information was taken from the design documentation filed for the building permit¹⁷, from articles in magazines of the period and from observation of the current state.

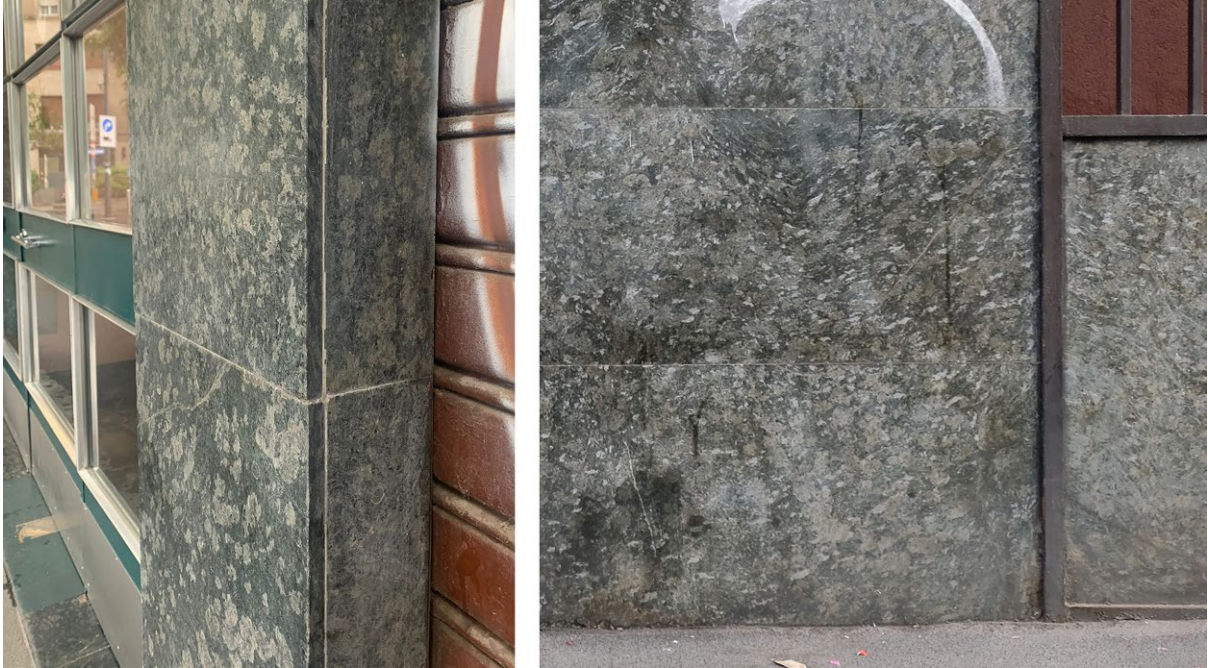
Figures 4a-b. On the left, detail of the cladding slabs on the ground floor of Casa Ghiringhelli, on the right, detail of the cladding slabs of Casa Toninello in the same material (photo M. Casanova, 2020).

The slabs, 50 or 95 cm wide, 111 cm high and 2 cm thick, arranged partly horizontally (between the shop windows) and partly vertically (at the top of the ground floor), were laid with a bed of cement mortar without clips or hooks (figs. 4a-b).

The finishes are made of ground Duralbo plaster in a colour that is described as “natural” in the publications of the construction period²⁰. From the external image of the building at the end of the works, there does not seem to have been any difference in colour, which is currently very pronounced, between the bow window and the walls set back at the sides. The central portion of the building on the ground floor and the blind infill of the lower strip of the fence closing the setbacks are clad with serpentine stone slabs measuring 65 cm by 91 cm and 2 cm thick arranged horizontally.

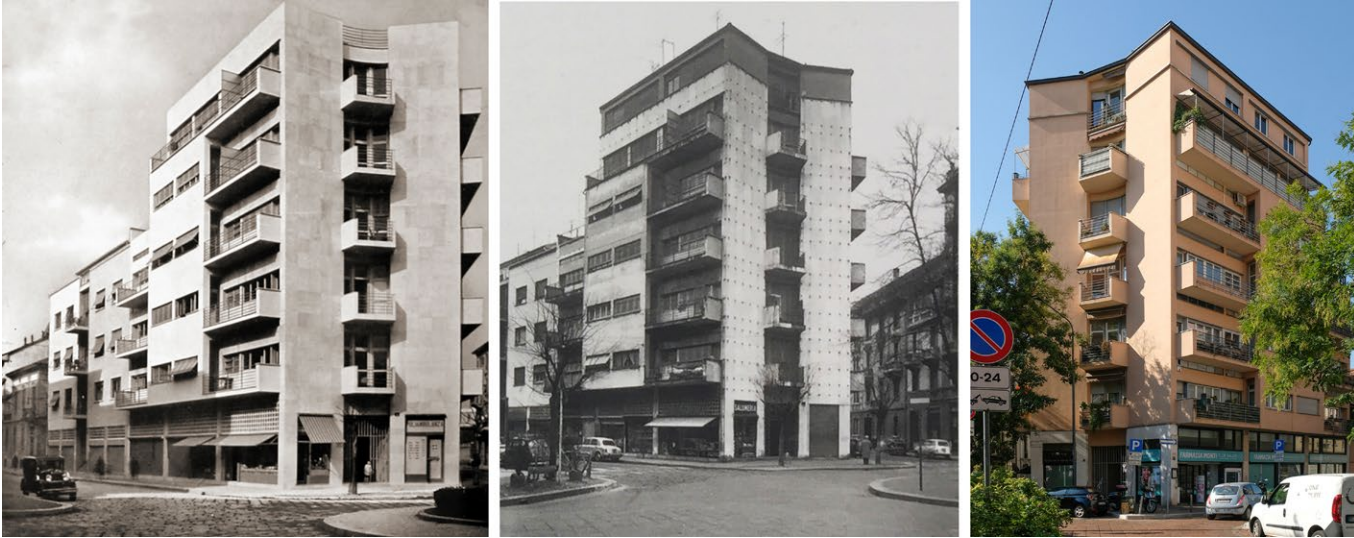
Figures 9a-c. Milano, Casa Lavezzari at the end of the working site in 1937 (on the left, AGT, photographs, Casa Lavezzari), after the raising and the application of fixing bosses (from CARRARO 2004, p. 221) and in 2019 (photo M. Casanova, 2019).

The stone cladding of the main body of Casa Lavezzari, as showed in the pictures attached to the documents for the raising⁴¹, was fixed with bosses placed on the corner of the slabs; for this kind of intervention, occurred in 1951, no building authorizations were required (figs. 9a-c). Afterwards, probably because of further problems concerning the detachment of the slabs, the cladding was removed completely. No documents have been found to testify the removal of the cladding, but from the pictures published, it is inferred that it took place between 1951 and 1985. The current cladding of the travertine base was introduced successively, while the Botticino cladding (or Trani marble) of the hall has been preserved.
