ArchistoR EXTRA 13 (2024)

Digital Mapping for the Neglected Built Heritage: the Case of Ferruzzano Superiore. Methodology and Outcomes

Morena Scaglia, Caterina Valiante

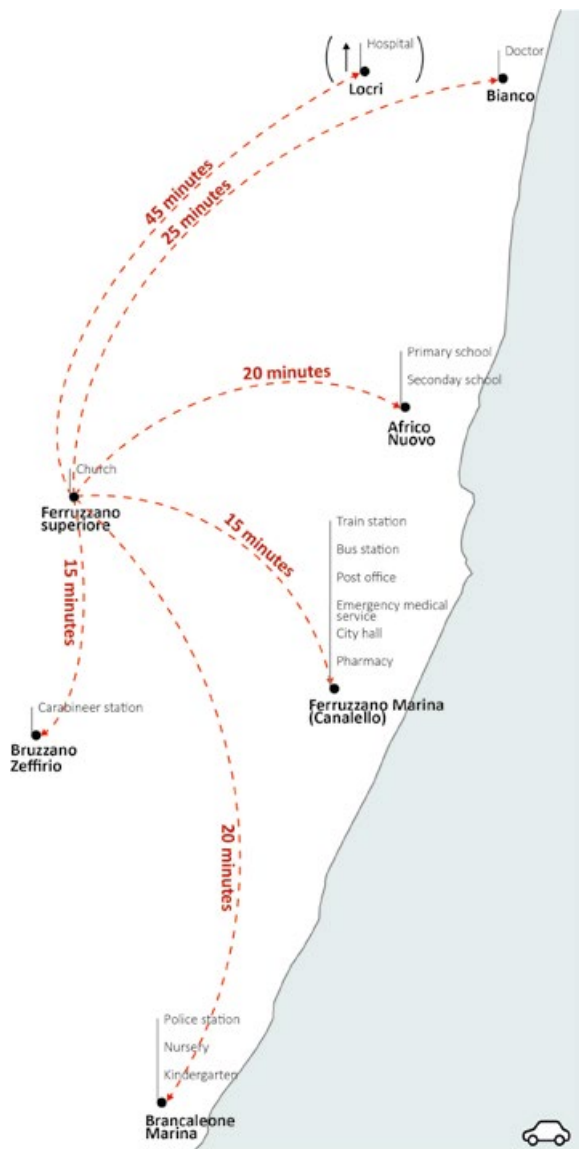
Figure 1. Distance of Ferruzzano Superiore from the main services (elaboration by the authors).

Located 65 km from the capital Reggio Calabria and 120 km from Catanzaro, Ferruzzano Superiore' residents for goods and services (education, health, mobility) lean on the coastal towns, from Bianco to Brancaleone, reachable at the most with 25 minutes by car, while the nearest hospital is in Locri, distant by the same means a little less than an hour (fig. 1).

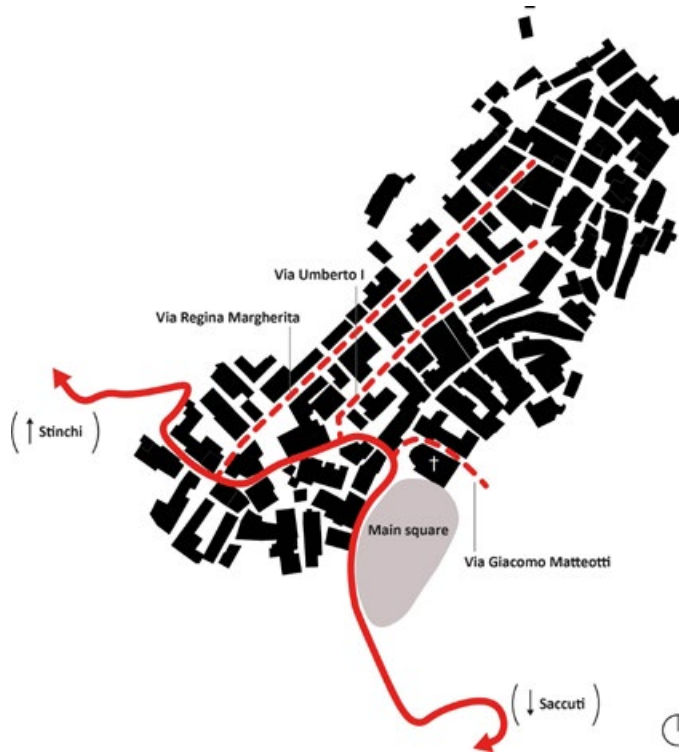
Figure 2. Accessibility to Ferruzzano Superiore and layout (elaboration by the authors).

The village is crossed by a driveway that reaches it from the "orecchione" of via Pioppo and continues to the locality of Stinchi after branching into via Giacomo Matteotti, and from there to the village's only square, via Umberto I, and its parallel, the wider and longer Via Regina Margherita (fig. 2).

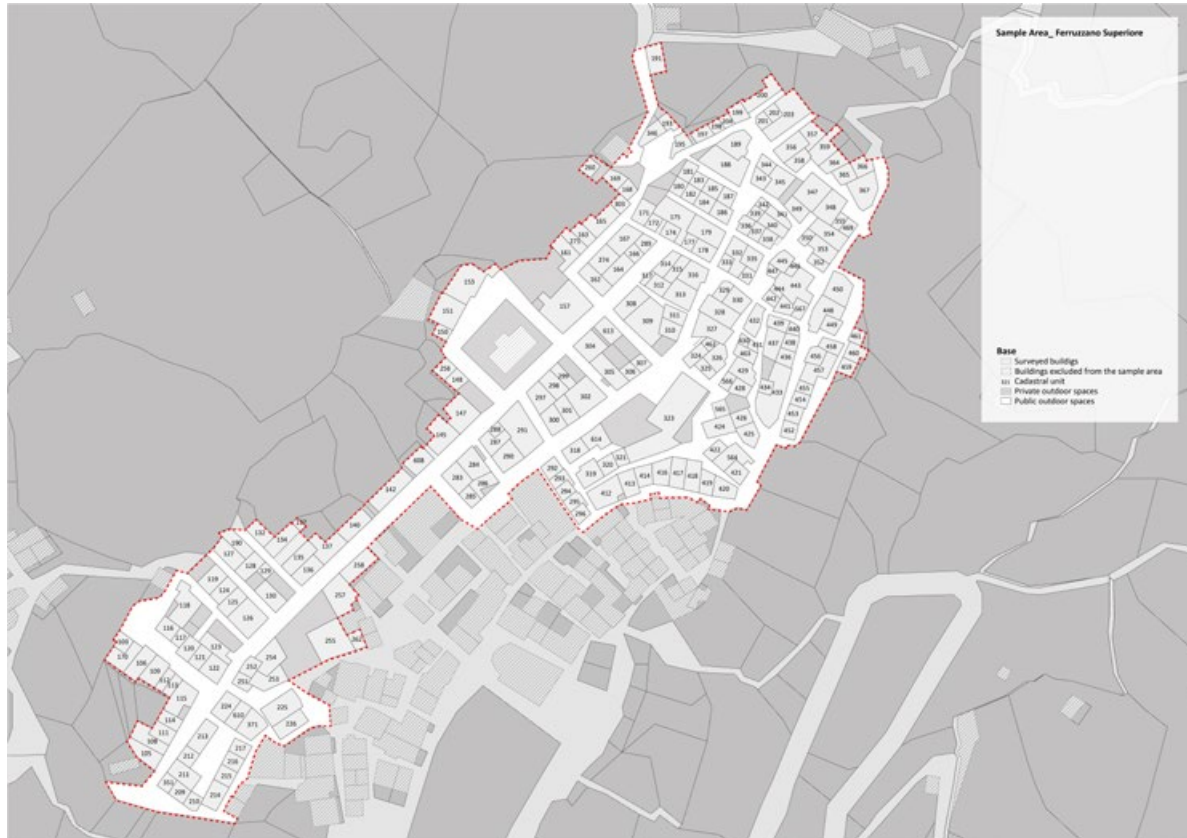
Figure 3. Cadastral map with surveyed comparts and sample area (elaboration by the authors).

To proceed in the mapping, the paper sheet 7 of the urban building cadastre of Ferruzzano Municipality has been taken as base where to identify the comparts to study (fig. 3). Having named them with a letter to support the subsequent identification of the cadastral parcels therein contained, the cataloguing of the information was conducted.

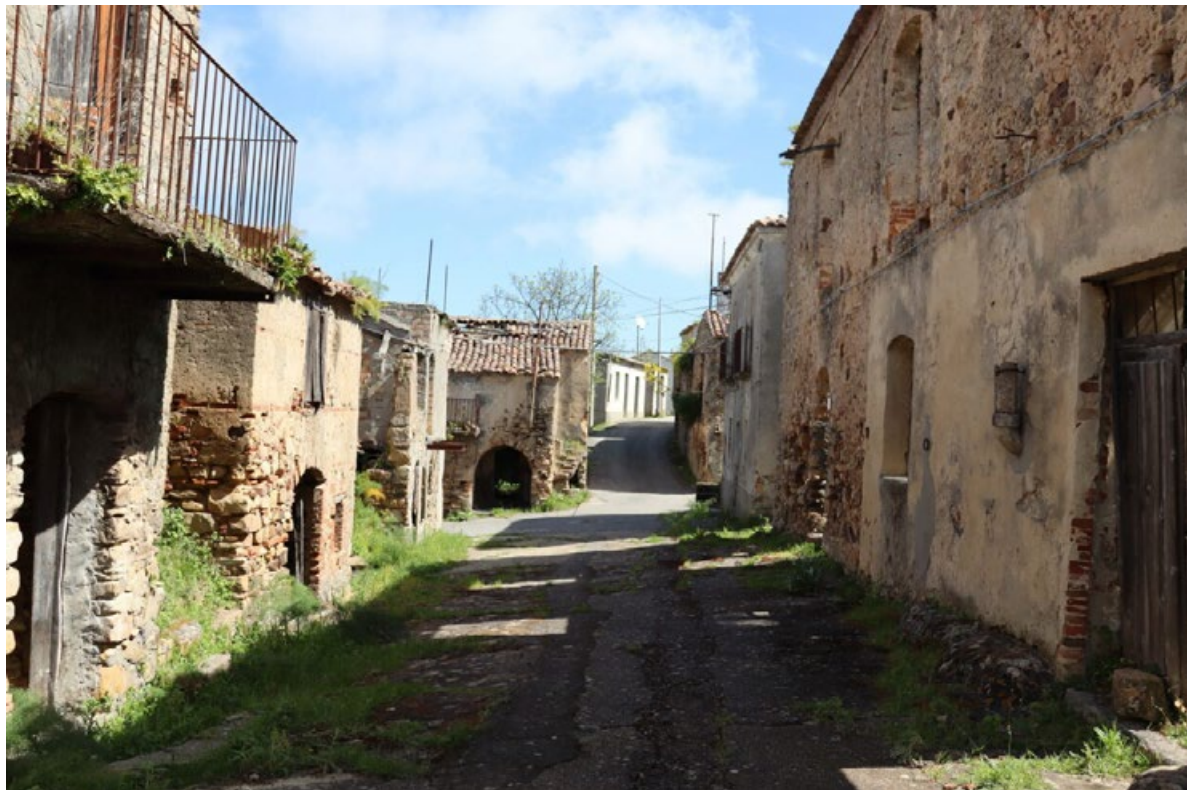
Figure 5. Abandoned buildings along Via Regina Margherita (photo M. Scaglia, 2023).

The listing of the characteristic elements of the fronts took into account the level of degradation afflicting them as well. “With no visible decay phenomena, with superficial and with widespread decay phenomena” are the three possible evaluation criteria to be included for any stone ashlar cornices and portals, pilasters and angles, string courses, *profferli*, arches, paintings and frescoes, relief decorations (stucco, plaster, etc.), under eaves cornices, corbels, lintels (wooden material, stone, CA, masonry, etc.) and railings/railings present (fig. 5).

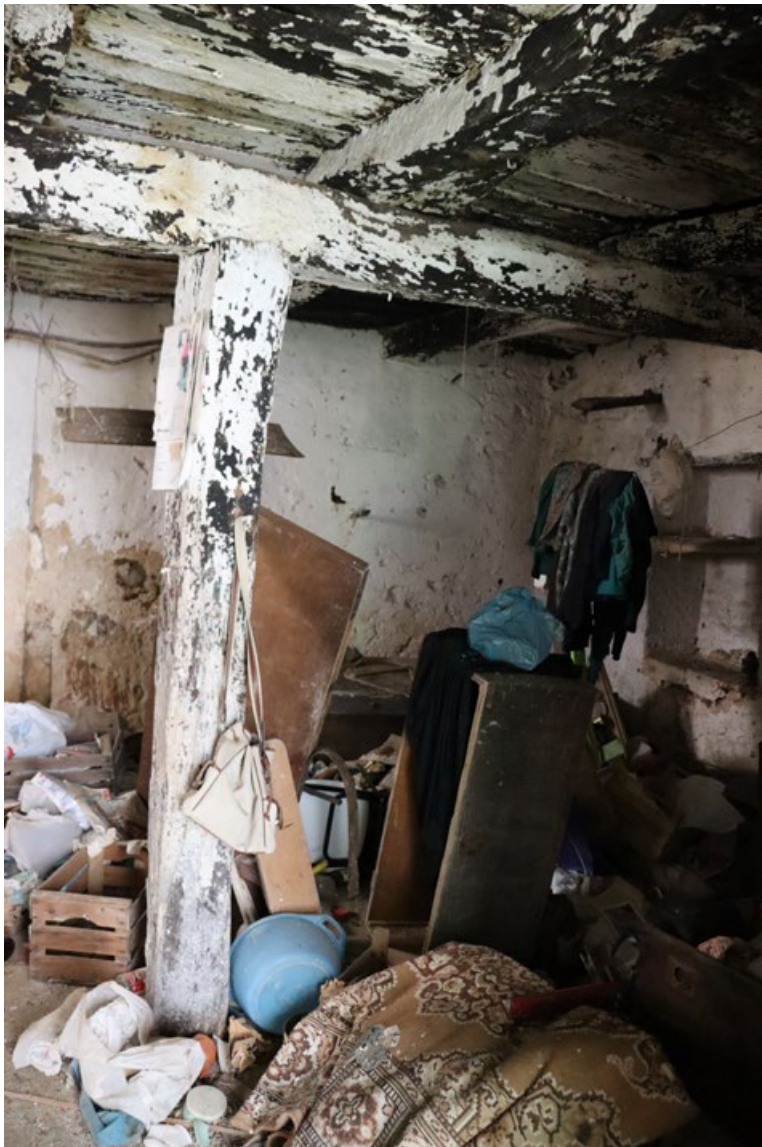
Figure 6. Characteristic presence of a central pillar in an abandoned building in via Pisacane (photo N. Sulfaro, 2023).

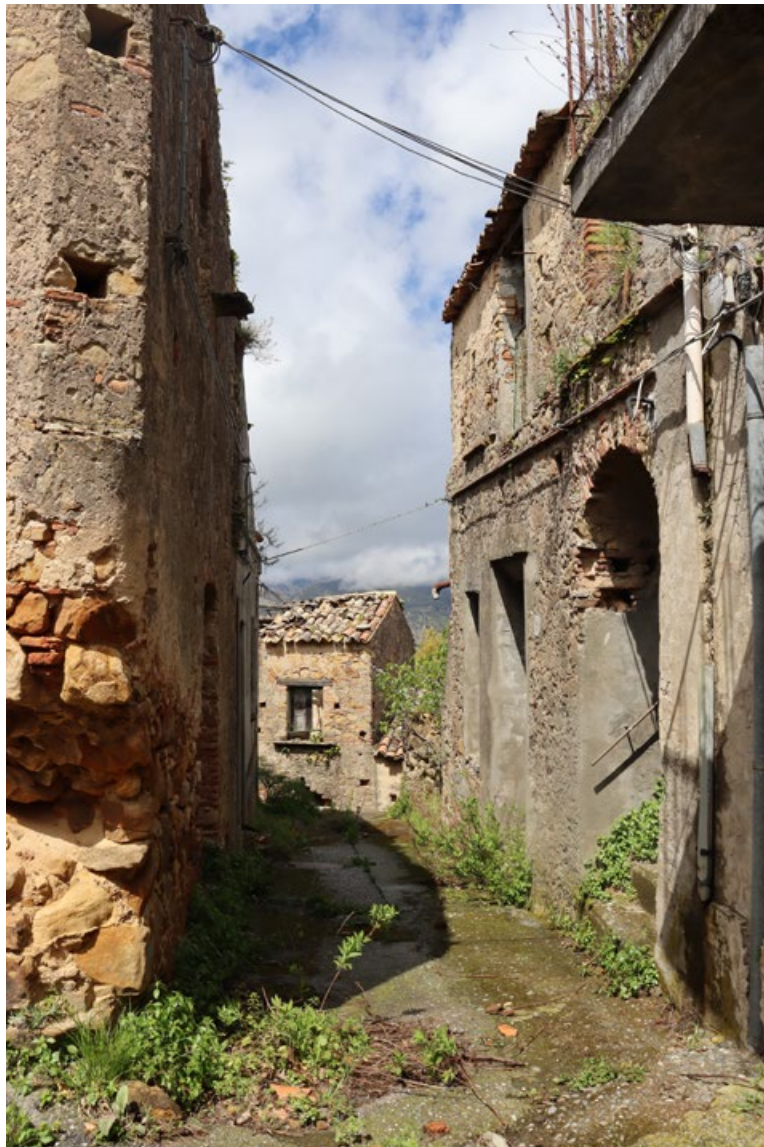
Figure 9. Ferruzzano Superiore, buildings in vico Cavour (photo C. Valiante, 2023).

The town of Ferruzzano Superiore, that according to some authors, was founded in the early 16th century³⁸, appears now as a homogeneous settlement, composed of limited-size buildings which are arranged into bigger aggregates and characterised mainly by two-storey constructions (fig. 9). Part of the built heritage was reconstructed after the catastrophic events that hit the village in the last century³⁹, as the inscriptions over some buildings report (dated 1927). Despite the simplicity of the structures, made of mixed masonry and wooden flooring and roofing, some very peculiar elements emerge. Most of the settlement lies on a rock outcrop, which was often carved for realising the ground floor or the basement, where these sandstone surfaces are still visible. From the structural point of view, the long-lasting frequency of seismic events led to interesting expedients that are quite diffused within the studied area, such as the mixed masonry provided with regular brick courses, or the wooden pillar placed at the midpoint of the main beam on the ground floor. Other peculiar elements concern the construction materials used for horizontal and interior vertical structures, among which the circular clay elements called “*carusi*” or “*caroselli*”⁴⁰, diffused in very delimited areas, used to build vaults of the most important and rich buildings of the town, and the lathwork

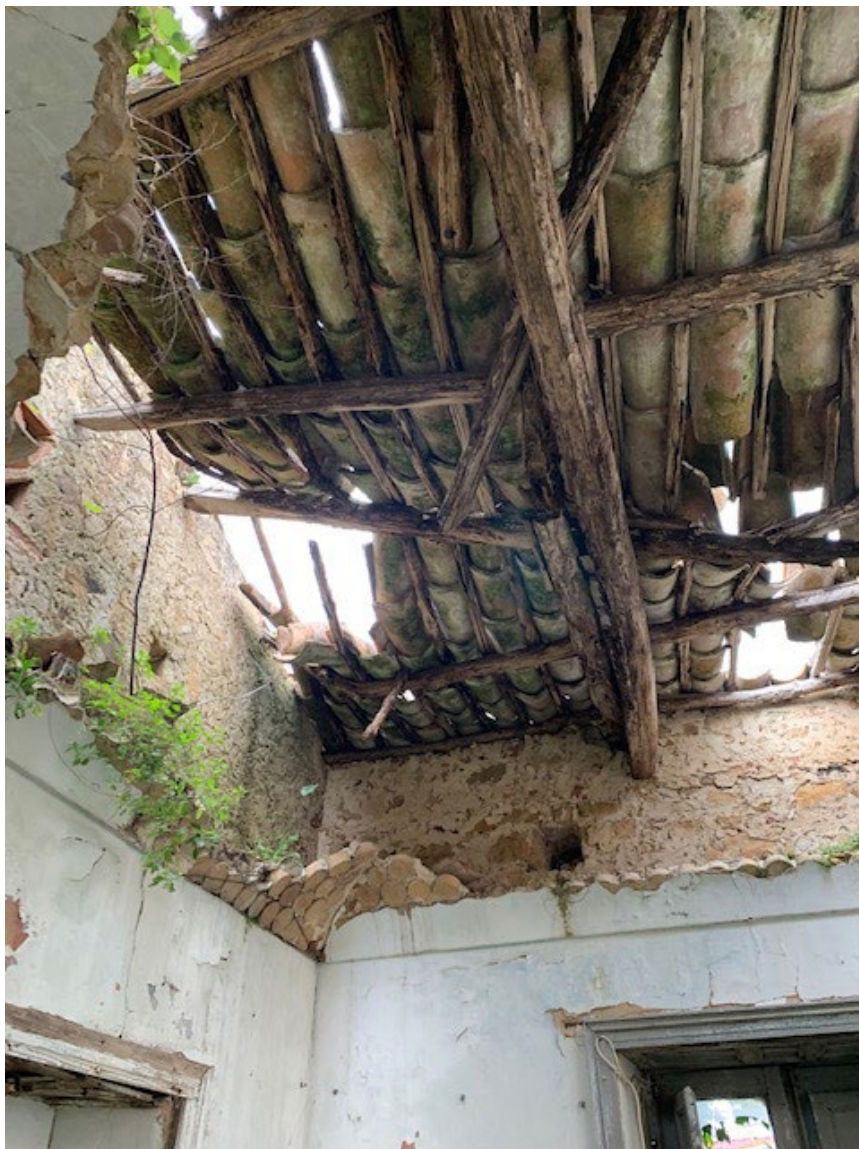
Figure 10. Ferruzzano Superiore.
Traces of a vault made of *carusi*
(photo C. Valiante, 2023).

used in the internal partitions. (figs. 10-11) The external elevations are usually finished with lime-based plaster and framed by simple decorations, such as string courses, cornices, and architraves. As will be discussed below, many of these features are now threatened or partially lost due to the poor state of conservation and the transformations that occurred.

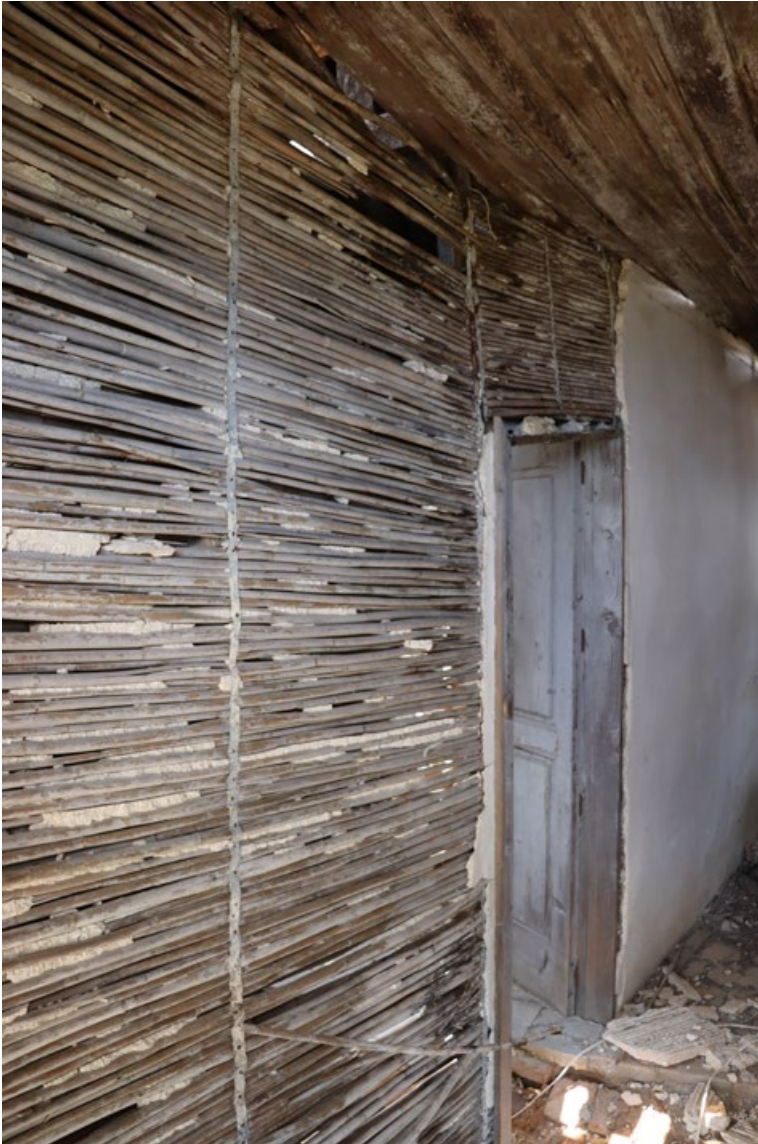
Figure 11. Ferruzzano Superiore.
Remains of the lathwork in the internal
partitions (photo C. Valiante, 2023).

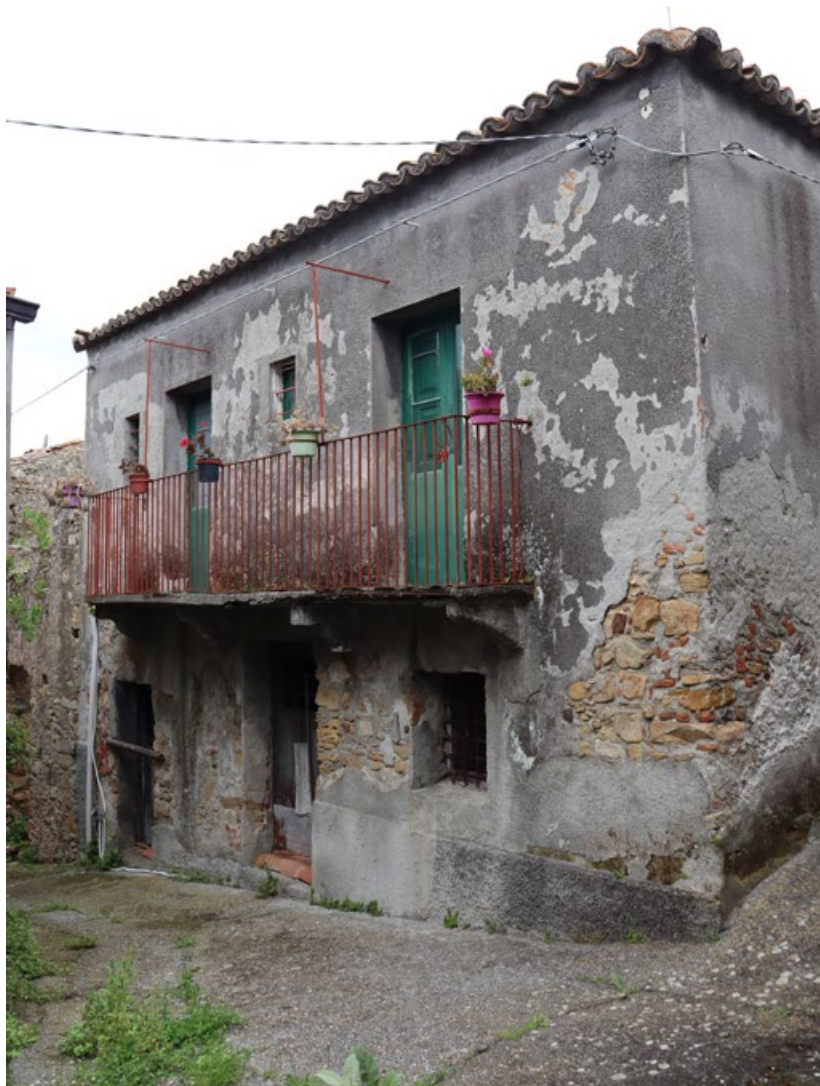
Figure 12. Ferruzzano Superiore. Partially preserved building in largo Colombo (photo C. Valiante, 2023).

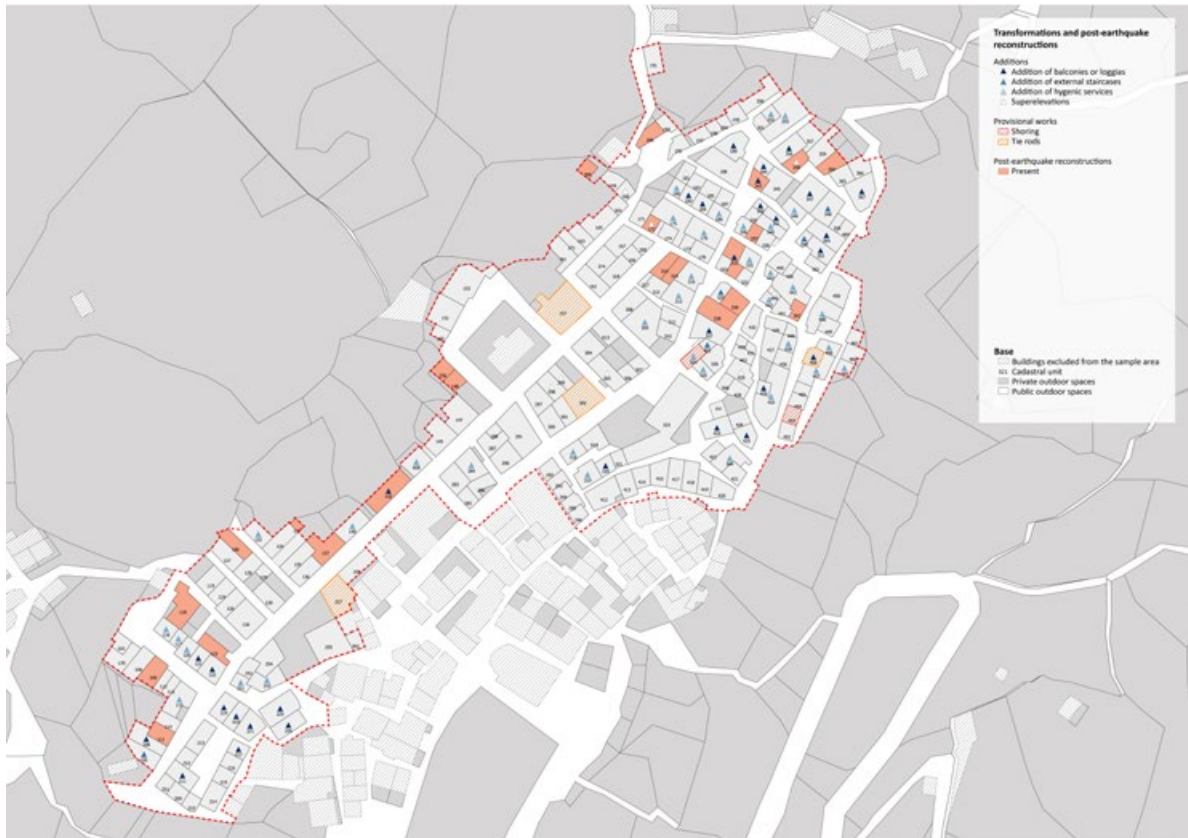
Figure 17. Transformations and post-earthquakes interventions (elaboration by the authors).

replace the previous existing stone “French balconies”⁴⁶, are usually built of armed concrete or a combination of steel beams and bricks, and they often show severe degradation due to the corrosion of the reinforcements. The added external volumes are often made of perforated bricks without finishings or armed concrete, so they have a wide impact on the external elevations. Furthermore, they are now affected by various decay phenomena due to abandonment and exposure to weather. In general, even though the morphology of the ancient settlement is still recognisable, the many punctual transformations – such as the above-described additions, the replacing of windows and external finishings⁴⁷ – that took place especially in recent times, showing no attention to the relationship with the existing heritage, partially changed the overall perception of the historical village. A more ancient, different kind of transformation was identified through the onsite investigations, which consisted of post-seismic reconstructions. These interesting interventions, in many cases, attest to a not-complete destruction of the existing structure since part of the stone or brick masonry was added to complete the damaged walls and often are characterised by a peculiar arrangement provided with regular brick courses in order to improve the resistance to earthquakes. The location of such interventions does not highlight any specific areas where the reconstructions were concentrated, and it is not possible to define part of the settlement that suffered more damages⁴⁸ (fig. 17).

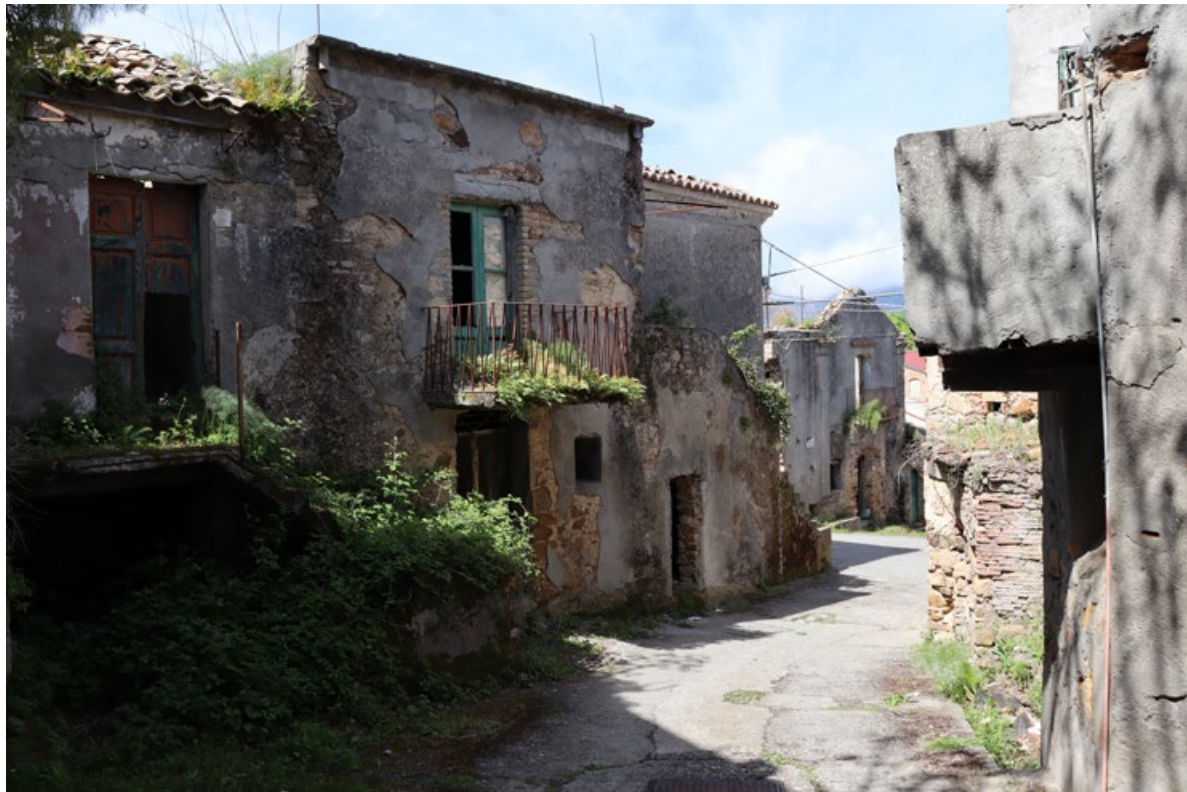
Figure 22. Ferruzzano Superiore. Buildings in via Manin (photo C. Valiante, 2023).

landscape and natural environment conditions, which lead to interesting paths and pleasant views. If such features could possibly foster new uses, various criticalities persist, primarily concerning the state of conservation of the built heritage and the overall accessibility of the single buildings and the entire settlement (fig. 22).
