Quando la conservazione incontra un edificio con curtain wall. Il caso di Torre Galfa in Milano

When Preservation Meets a 20th-Century Building with Curtain Wall. The Case of the Torre Galfa in Milan

Davide Del Curto, Chiara Stanga

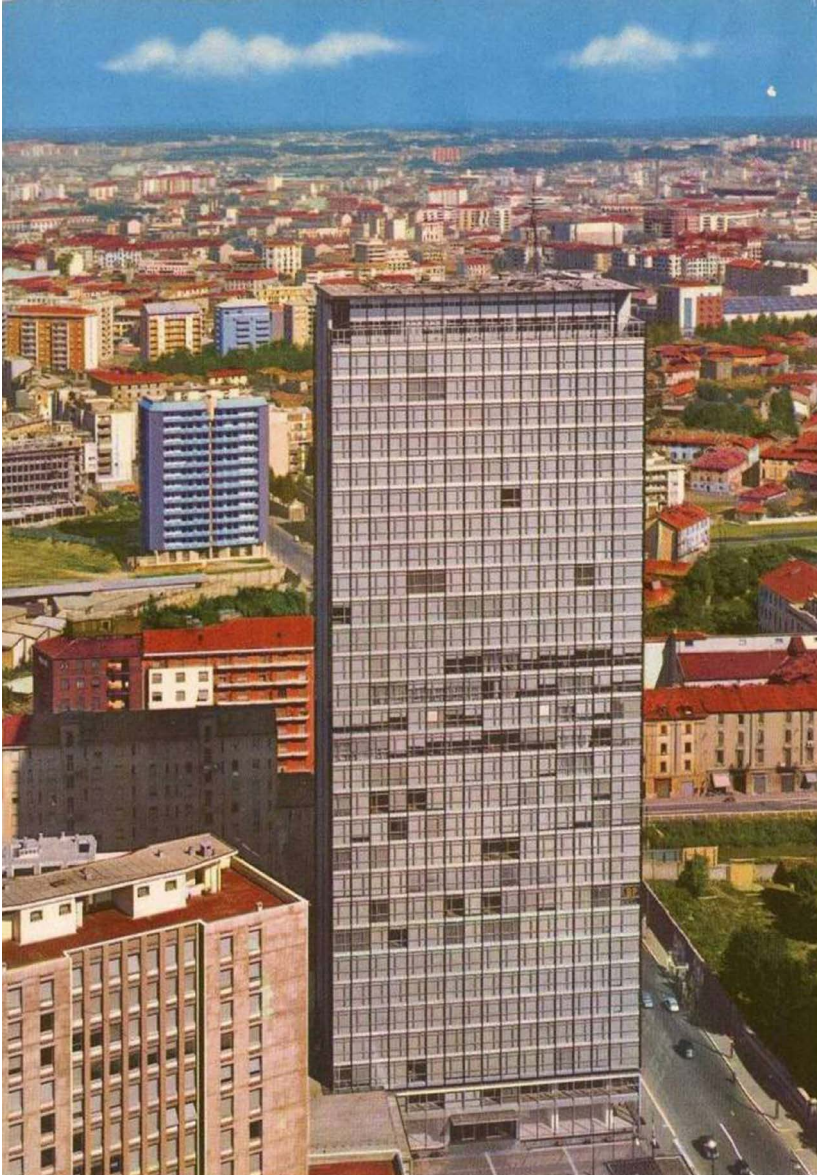
Figure 2. Milan, Galfa Tower façade with curtains, view from Pirelli Tower rooftop (1960s-postcard, collection of the authors).

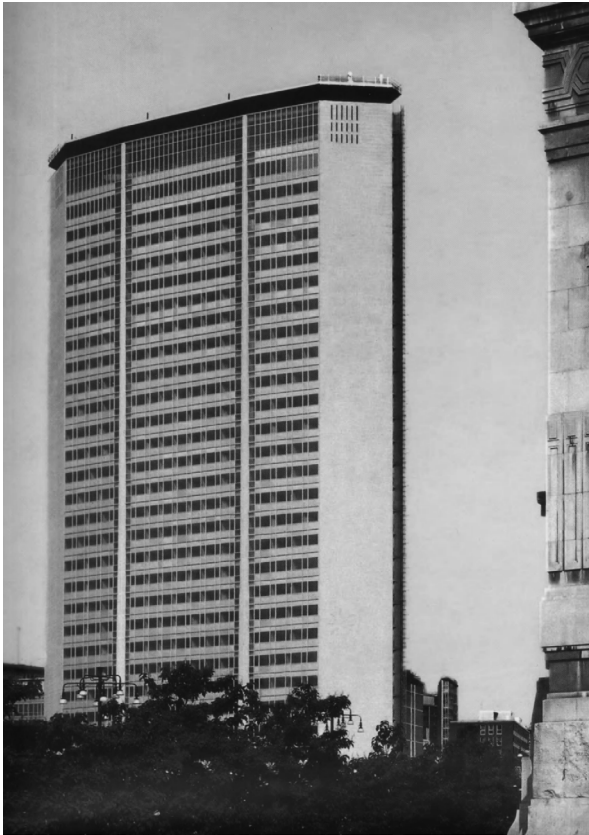
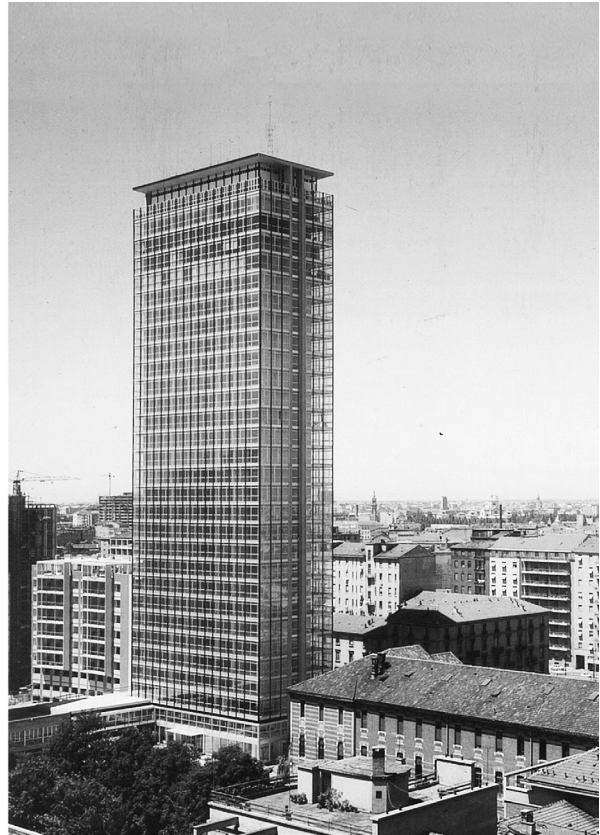
the interiors from the solar radiation (fig. 2). The HVAC channels occupied a limited thickness at the edge of the slab, thus opaque parapets were not needed to hide fan coils, as it was for the nearby Pirelli Tower (figg. 3-4). The overall design of the façade is therefore dominated by transparent surfaces (fig. 5). The façade was produced with techniques on the edge between craftsmanship and industry, thus testifying the fragmentation of the manufacturing sector in the 1950s, where most Italian companies had small-medium dimensions⁴¹.

Figure 4. Comparison between the curtain wall of Pirelli Tower and Galfa Tower: as-built. Pirelli tower curtain wall includes opaque parapets and fanlights to hide fan coil units and countertops (CRIPPA 2007, left). Thanks to the limited thickness of the air-ducts, Galfa Tower has a fully transparent curtain wall (courtesy of Architect Bega Archive, right).

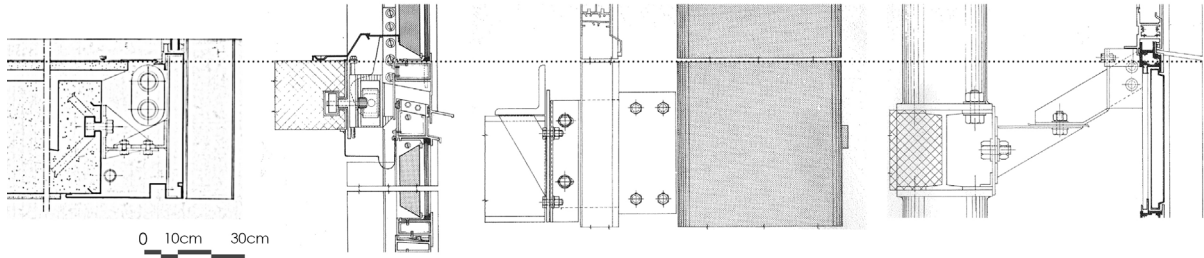
Figure 5. Comparison among 1950-60s curtain wall-slab connections. Dot line represents the floor level. From left to right: Galfa Tower, Milan, 1956-59 (courtesy of Architect Bega Archive); Pirelli Tower, Milan, 1956-60 (ROMANELLI, SCAPACCINO 1979); Esso Standard headquarters, Rome, 1963-1964 (ROMANELLI, SCAPACCINO 1979); RAI-TV headquarters, Rome, 1967 (ROMANELLI, SCAPACCINO 1979).

above. This connection shows that the curtain wall was probably installed from the inside rather than the outside, thus accelerating the construction process. The curtain wall was totally assembled on-site in less than three months, after the concrete structure was finished. The easy-to-handle metal profiles allowed this rapid construction. The making of mullions and frames took one month, the glass panes were then installed⁵⁰.
