# The Outer Surfaces of the Residential Buildings Designed by Giuseppe Terragni. Plasters, Stone Cladding and Prefabricated Elements to the Test of Time

Marta Casanova

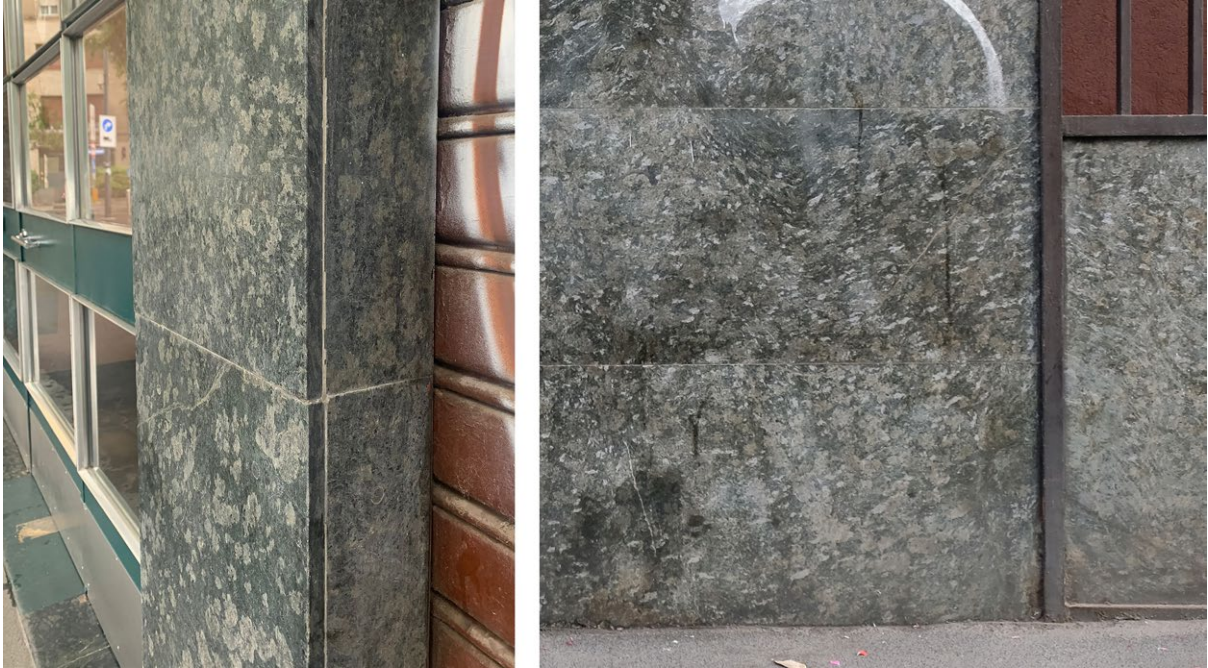
Figures 4a-b. On the left, detail of the cladding slabs on the ground floor of Casa Ghiringhelli, on the right, detail of the cladding slabs of Casa Toninello in the same material (photo M. Casanova, 2020).

The slabs, 50 or 95 cm wide, 111 cm high and 2 cm thick, arranged partly horizontally (between the shop windows) and partly vertically (at the top of the ground floor), were laid with a bed of cement mortar without clips or hooks (figs. 4a-b).

The finishes are made of ground Duralbo plaster in a colour that is described as “natural” in the publications of the construction period<sup>20</sup>. From the external image of the building at the end of the works, there does not seem to have been any difference in colour, which is currently very pronounced, between the bow window and the walls set back at the sides. The central portion of the building on the ground floor and the blind infill of the lower strip of the fence closing the setbacks are clad with serpentine stone slabs measuring 65 cm by 91 cm and 2 cm thick arranged horizontally.

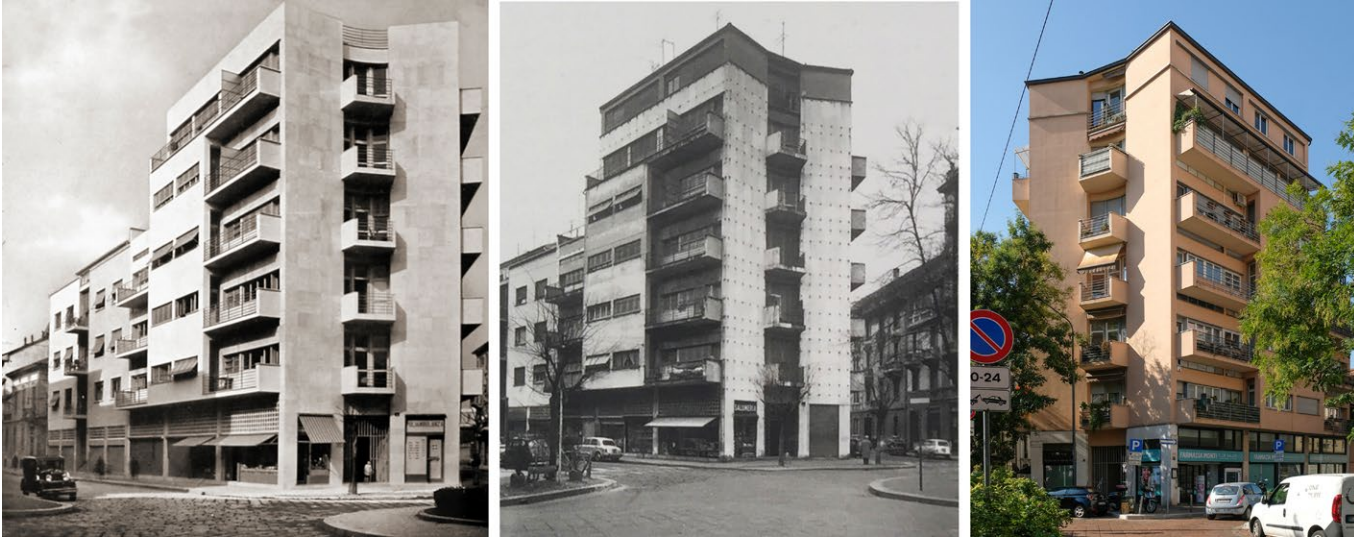
Figures 9a-c. Milano, Casa Lavezzari at the end of the working site in 1937 (on the left, AGT, photographs, Casa Lavezzari), after the raising and the application of fixing bosses (from CARRARO 2004, p. 221) and in 2019 (photo M. Casanova, 2019).

The stone cladding of the main body of Casa Lavezzari, as showed in the pictures attached to the documents for the raising<sup>41</sup>, was fixed with bosses placed on the corner of the slabs; for this kind of intervention, occurred in 1951, no building authorizations were required (figs. 9a-c). Afterwards, probably because of further problems concerning the detachment of the slabs, the cladding was removed completely. No documents have been found to testify the removal of the cladding, but from the pictures published, it is inferred that it took place between 1951 and 1985. The current cladding of the travertine base was introduced successively, while the Botticino cladding (or Trani marble) of the hall has been preserved.
